Chapter 4 | Technical Findings

Chapter 4.1 | Flow Path

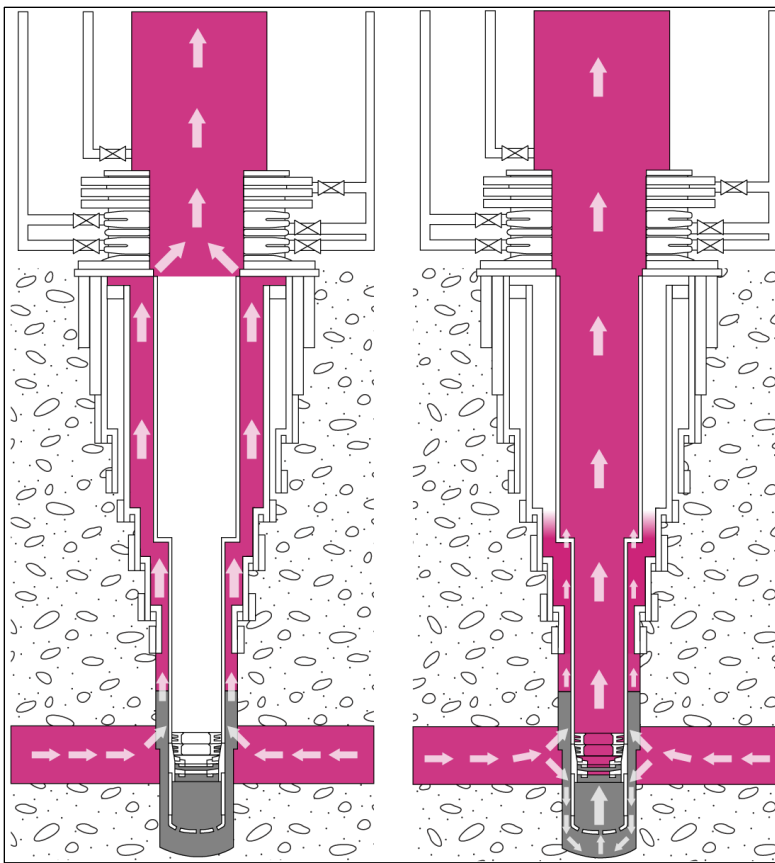
Figure 4.1.1. Possible flow paths for hydrocarbons.

Hydrocarbons can reach the surface by traveling up the annulus and through the seal assembly (left). Hydrocarbons can also enter and migrate up the inside of the production casing, through a number of possible flow paths (right).

The Chief Counsel's team finds that hydrocarbons came to the surface by traveling through the inside of the production casing, as seen on the right side of Figure 4.1.1. It is almost certain that hydrocarbons entered the production casing because of a failure of the shoe track cement. However, the Chief Counsel's team cannot entirely rule out the possibility that hydrocarbons may have entered the production casing from the annulus through a breach in the production casing somewhere near the bottom of the casing.

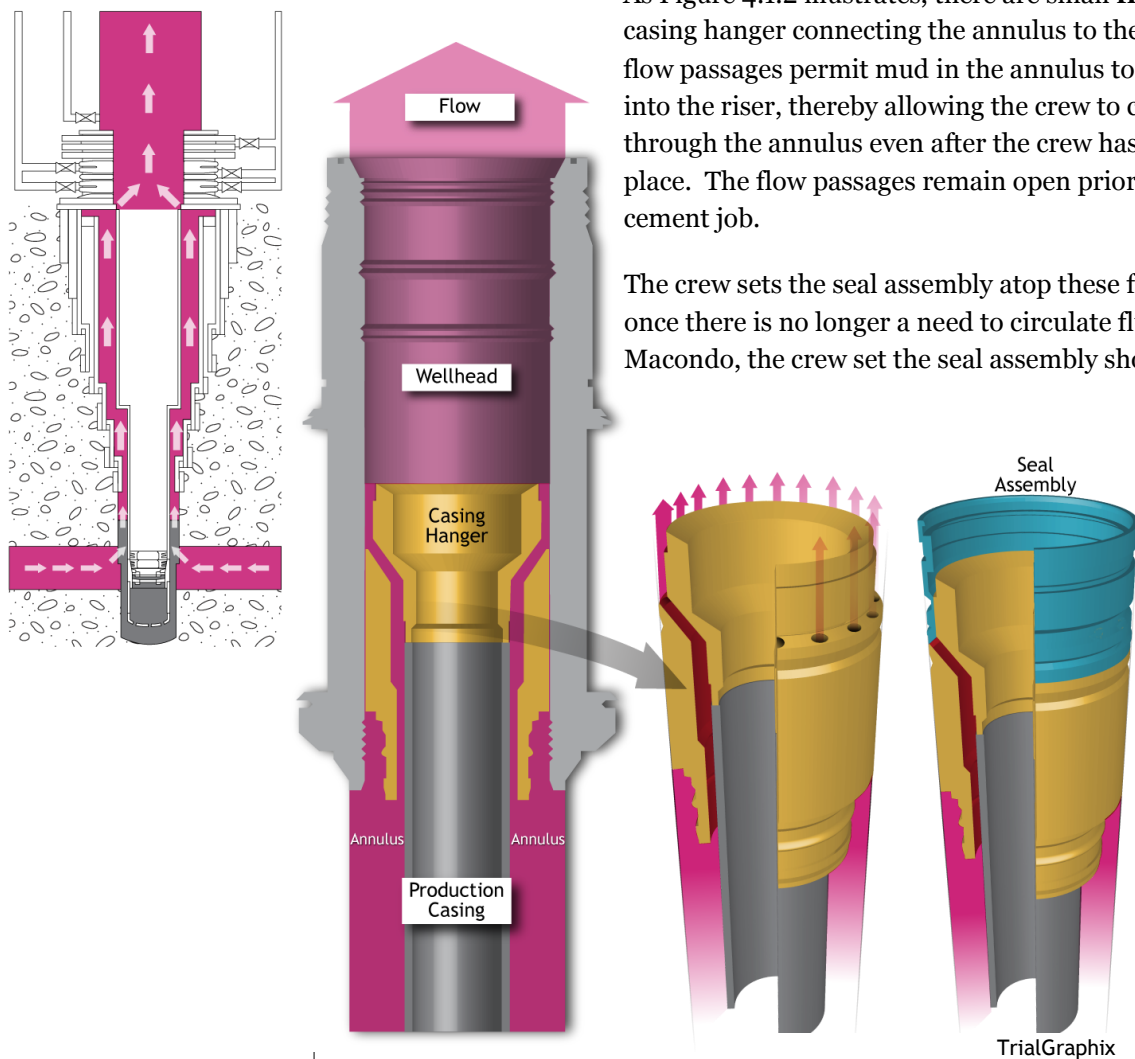
Figure 4.1.2.
Flow through the seal assembly.

As Figure 4.1.2 illustrates, there are small **flow passages** through the casing hanger connecting the annulus to the inside of the wellhead.³ The flow passages permit mud in the annulus to flow into the wellhead and up into the riser, thereby allowing the crew to circulate drilling fluids through the annulus even after the crew has set the production casing in place. The flow passages remain open prior to and during the final cement job.

First, there could have been a leak through the flow passages. This might have occurred because debris obstructed the seal area during the setting process, the seal failed to expand and set properly, or the seal dislodged after it was set.⁴

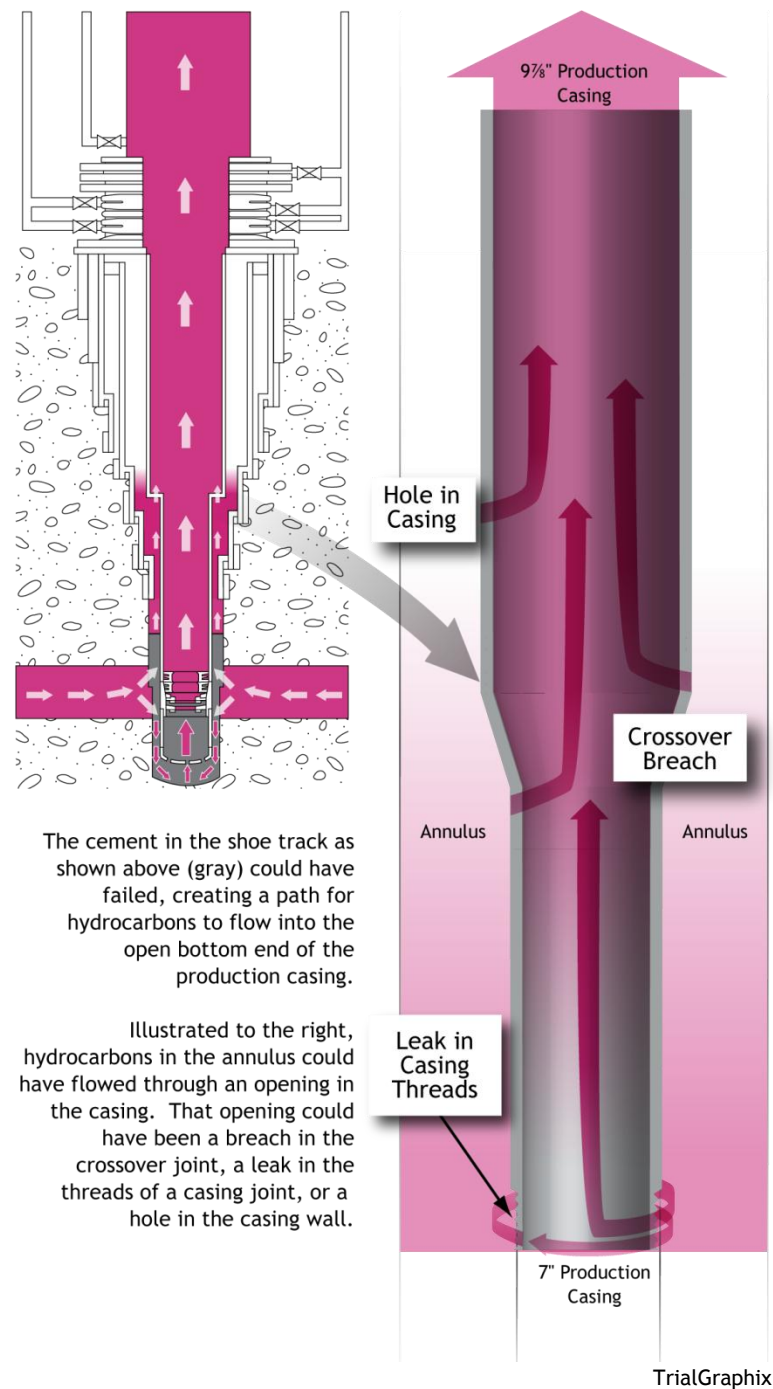
Figure 4.1.3. Flow up the production casing.

Second, hydrocarbons in the annulus could have flowed into the production casing through an opening in the casing. That opening could have been a breach in the 9⁷/₈-inch × 7-inch tapered crossover joint,⁸ a leak in the threads of a casing joint,⁹ or a hole in the casing wall, as illustrated in Figure 4.1.3.

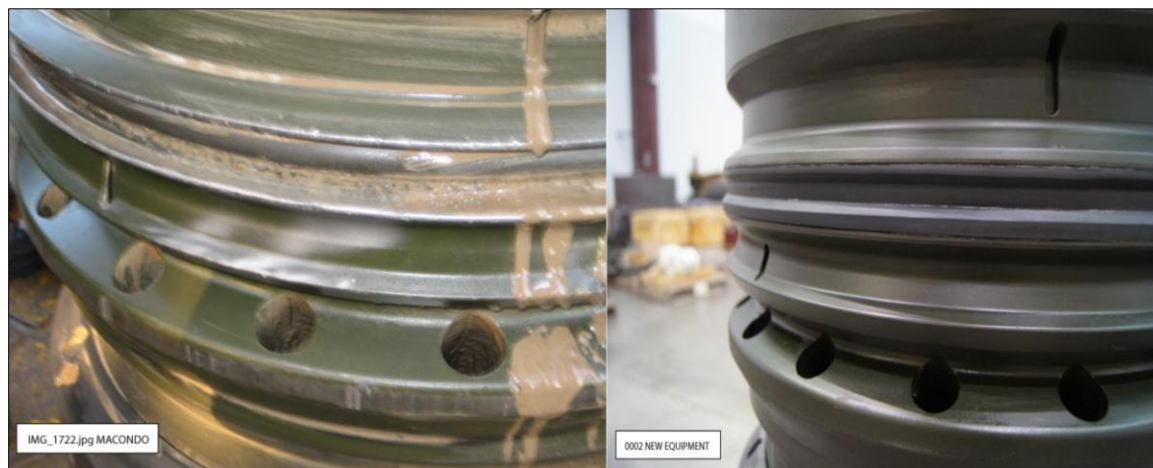
Figure 4.1.6. Undamaged metal edges of the casing hanger and seal assembly.

The casing hanger and seal assembly contain a series of circular metal lips (as shown in Figure 4.1.6) that protrude and fit inside a corresponding profile on the inside of the wellhead housing. The parts fit together very precisely to create a metal-to-metal seal. If the casing hanger had lifted out of place, it would have caused significant damage to these metal lips. Post-blowout photographs of the casing hanger and seal assembly show no such wear.⁴⁹

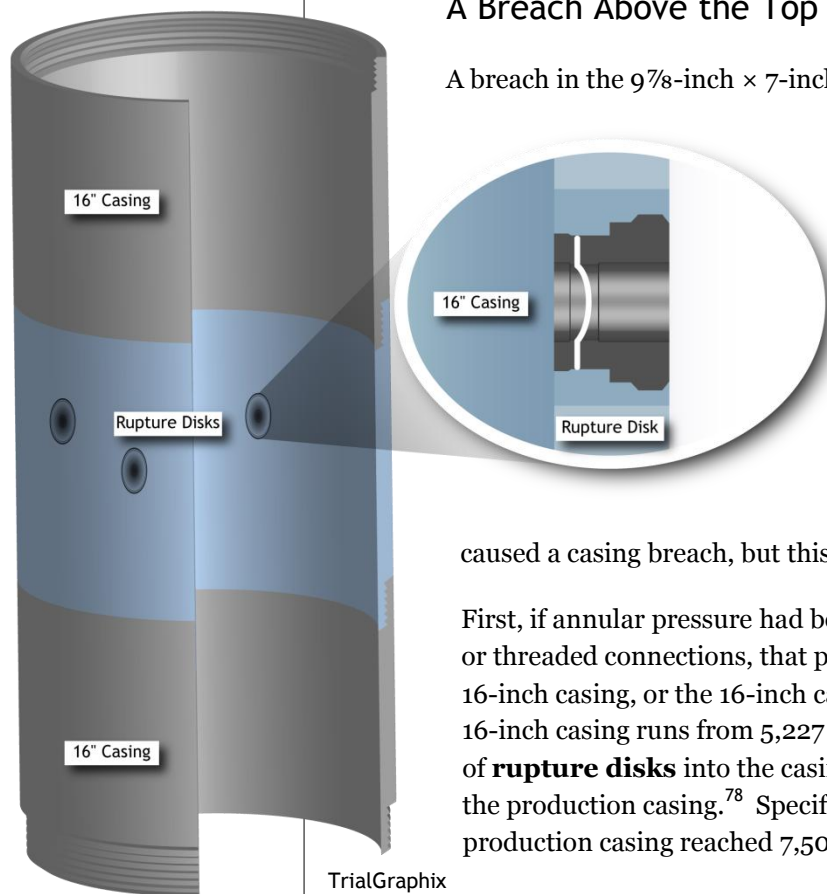
Figure 4.1.9. 16-inch casing and rupture disks.

First, if annular pressure had been sufficient to cause a breach in the production casing or threaded connections, that pressure should first have caused rupture disks in the 16-inch casing, or the 16-inch casing itself, to burst (shown in Figure 4.1.9). The 16-inch casing runs from 5,227 to 11,585 feet below sea level.⁷⁷ BP installed three sets of **rupture disks** into the casing wall. The rupture disks were designed to fail before the production casing.⁷⁸ Specifically, if pressure between the 16-inch casing and the production casing reached 7,500 psi, the rupture disks should have burst outward.⁷⁹

This pressure is, by design, less than the 11,140 psi that the production casing and its threaded connections are designed to withstand.⁸⁰ Even if the rupture disks did not function as designed, the 16-inch casing probably would have failed in some manner once pressures significantly exceeded 6,920 psi.⁸¹ But it appears that neither the rupture disks nor the 16-inch casing failed. [Chapter 4.2](#) discusses this issue in more detail.

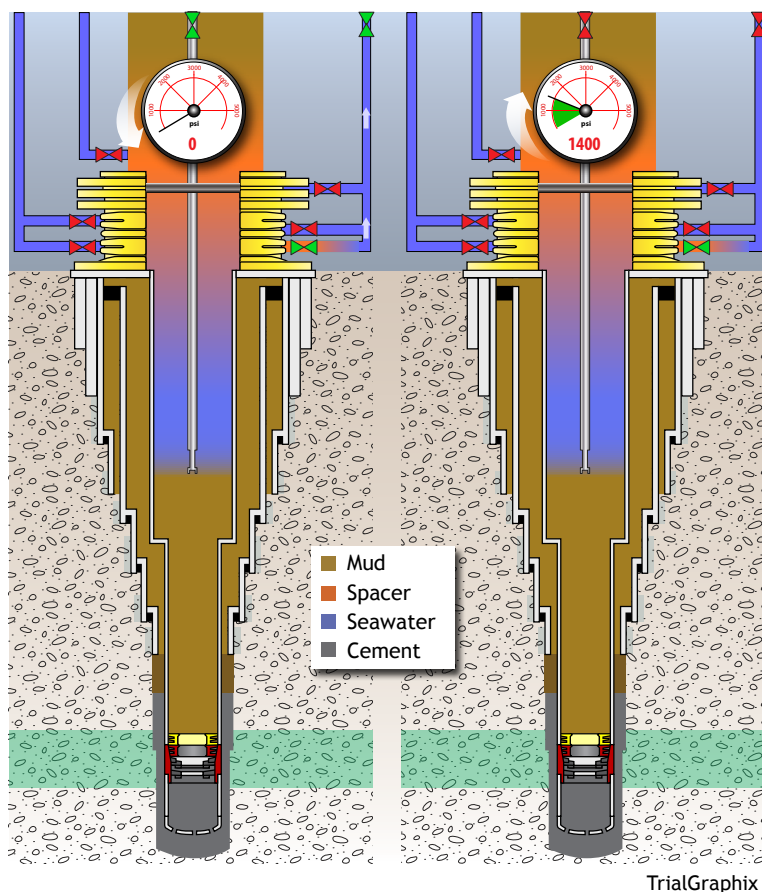
Figure 4.6.16. 5:53 p.m.

The rig crew bled drill pipe pressure down for a third time, this time through the kill line. Witnesses reported that three to 15 barrels were returned as the drill pipe reached 0 psi (left). When the drill pipe was shut, the drill pipe pressure rose to 1,400 psi. According to BP witnesses, the Transocean rig crew attributed this rise to a “bladder effect.” A 15-barrel return would have been excessive, and the rise of drill pipe pressure to 1,400 psi was a clear sign that the negative pressure test had failed (right).

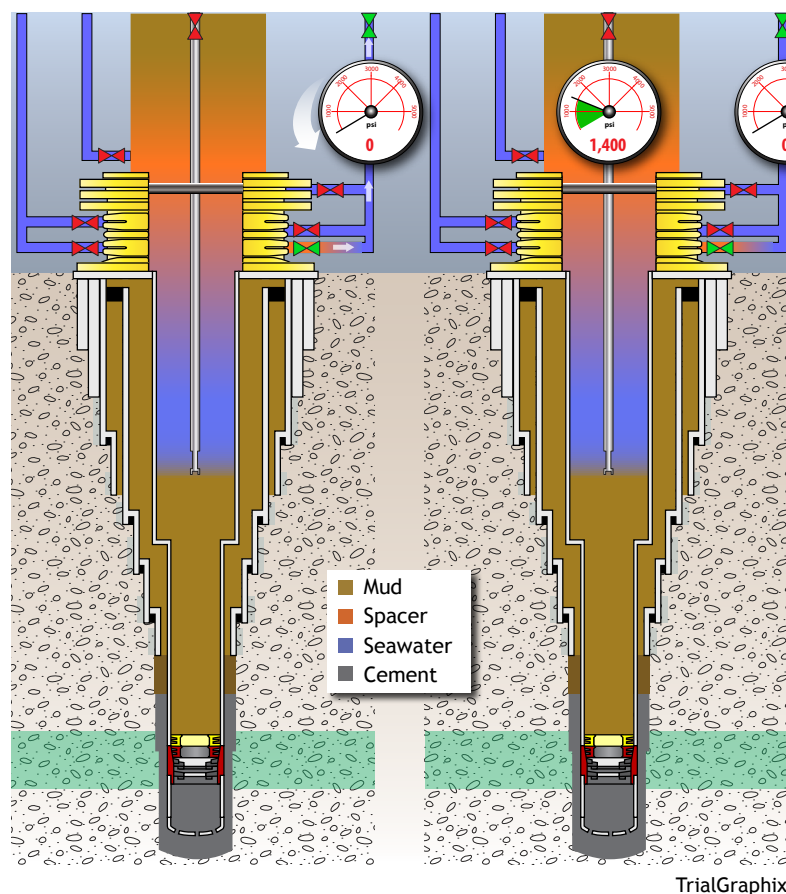
Figure 4.6.18. 6:40 p.m.

The rig crew conducted a negative pressure test on the kill line. The rig crew reduced the pressure on the kill line to 0 psi, bleeding an insignificant amount of water (left). No flow or pressure buildup was observed on the kill line, which on its own would have been a successful negative pressure test. However, the 1,400 psi on the drill pipe remained and was never properly accounted for (right).

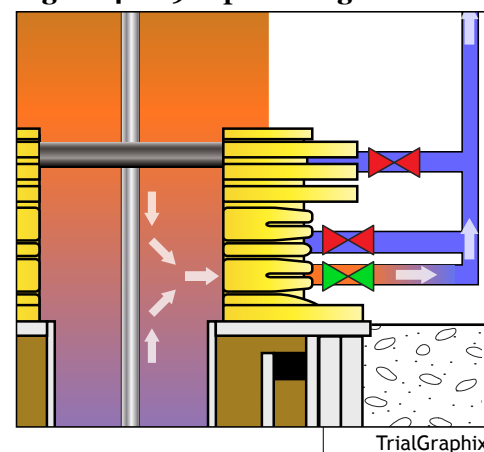
Figure 4.6.19. Spacer migration.

Leftover lost circulation material used as spacer for the negative pressure test could have migrated into the kill line during bleeds.
