Chapter 4 | Technical Findings

Chapter 4.1 | Flow Path

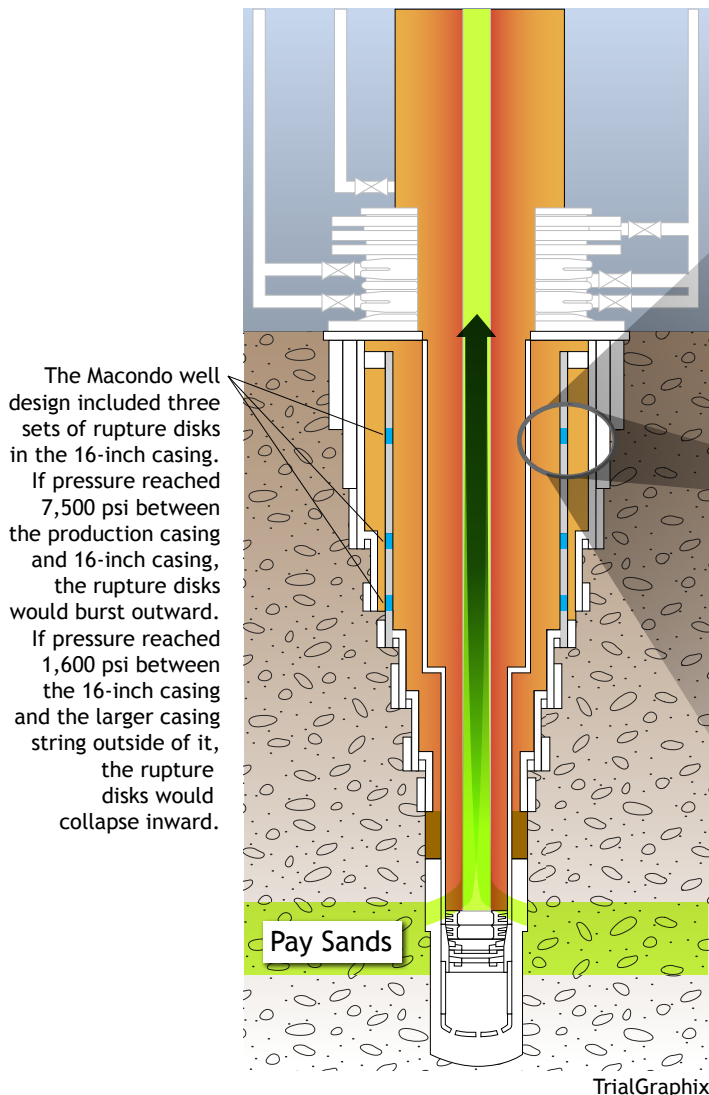
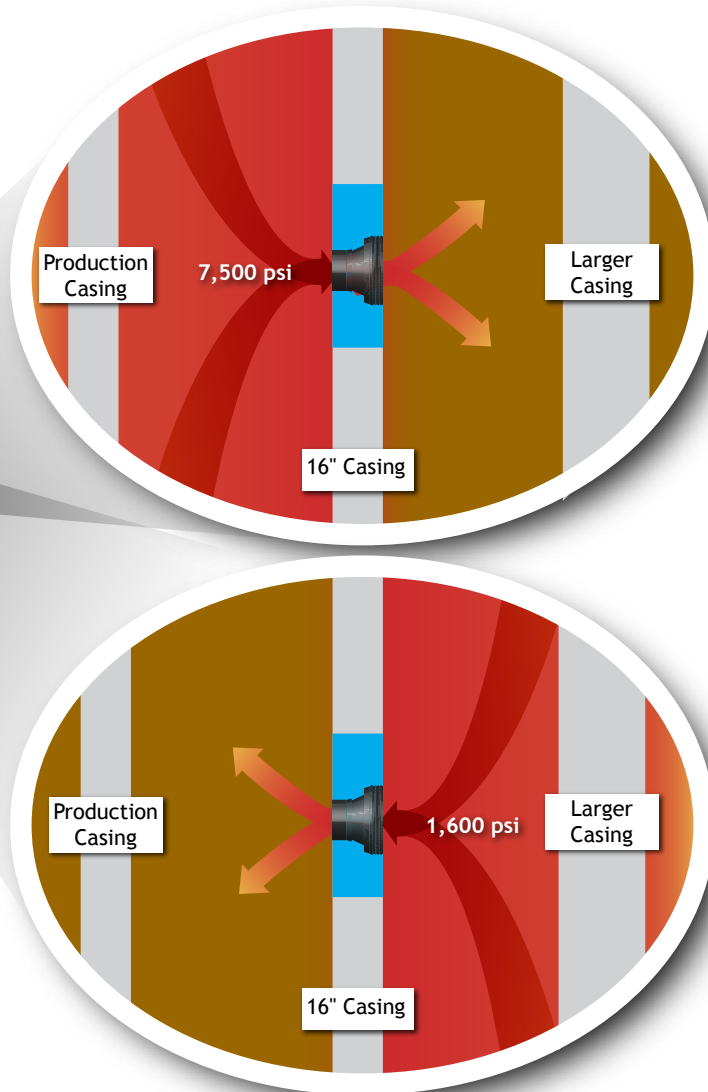
Figure 4.2.5. Rupture disks.

First, if annular pressure had been sufficient to cause a breach in the production casing or threaded connections, that pressure should first have caused rupture disks in the 16-inch casing, or the 16-inch casing itself, to burst (shown in Figure 4.1.9). The 16-inch casing runs from 5,227 to 11,585 feet below sea level.⁷⁷ BP installed three sets of **rupture disks** into the casing wall. The rupture disks were designed to fail before the production casing.⁷⁸ Specifically, if pressure between the 16-inch casing and the production casing reached 7,500 psi, the rupture disks should have burst outward.⁷⁹

Once ruptured, the disks would leave small holes in the 16-inch casing through which pressure could bleed into the surrounding rock formation.²²

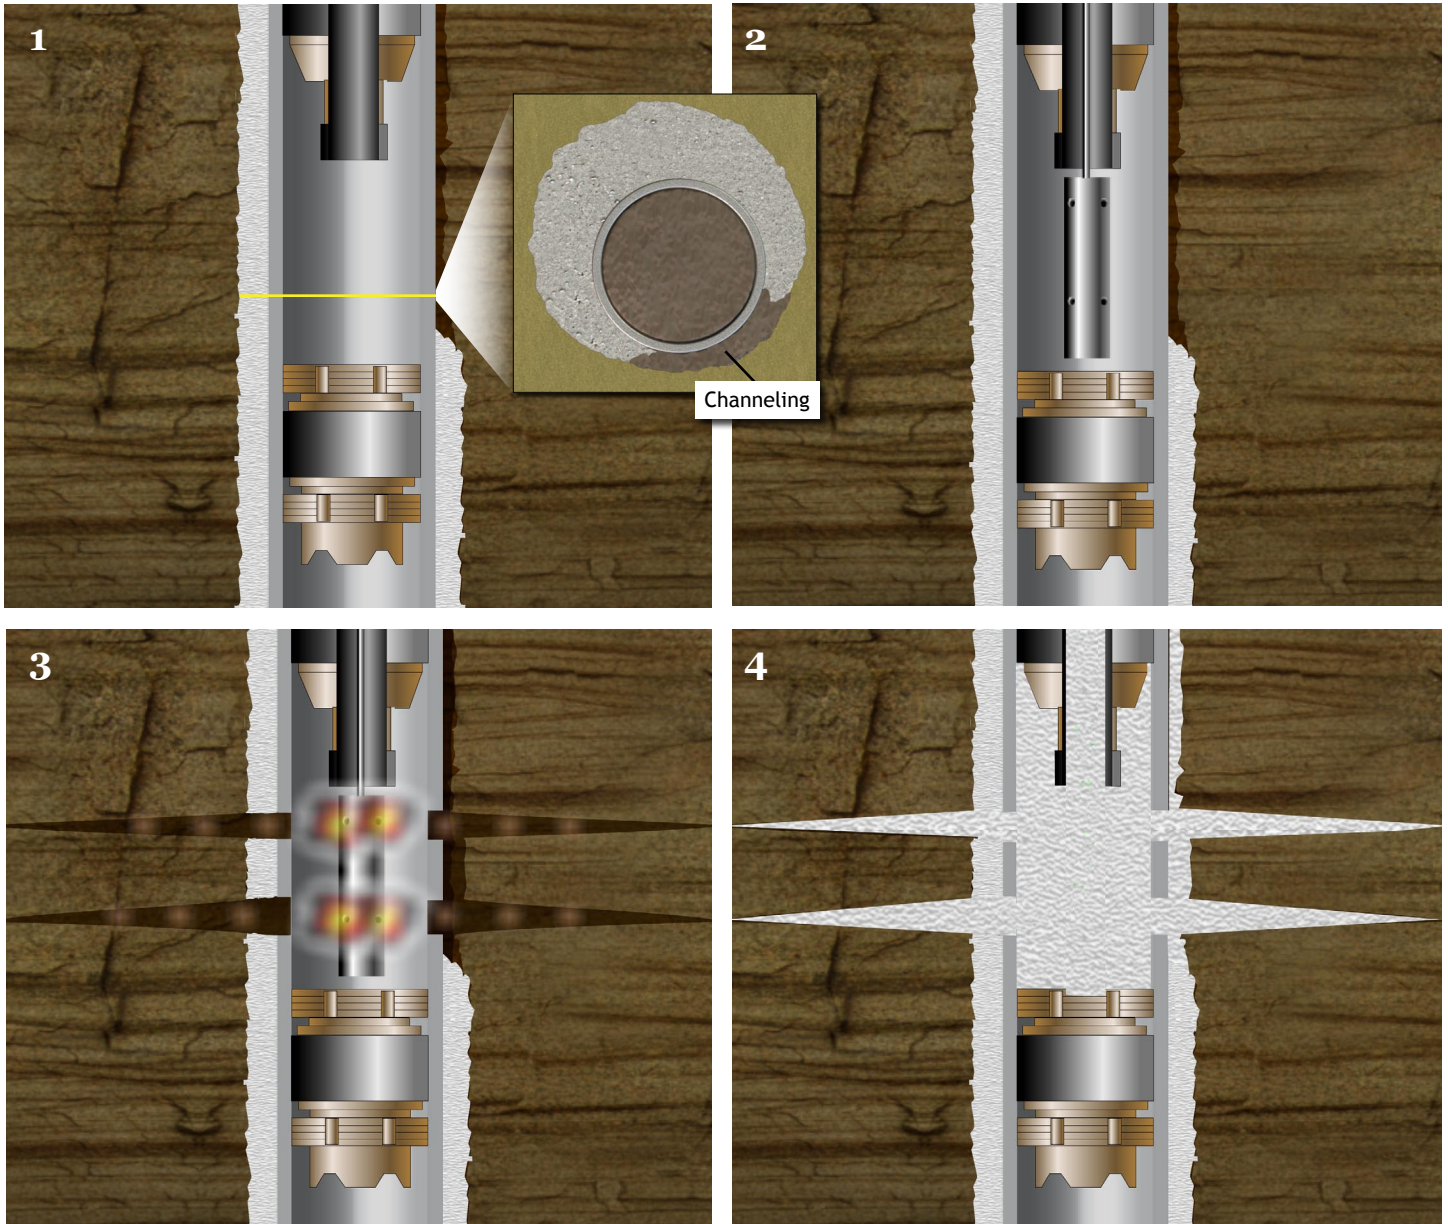
Figure 4.3.12. Remedial cementing—squeeze job.

From upper left: 1) Poor centralization has led to channeling; 2) a bridge plug is placed below the remediation area, and a packer is positioned above; 3) a perforation gun is lowered and fires shells through the casing and into the formation; 4) cement is pumped into the area, forced through the perforations, and into the formation, creating a seal.

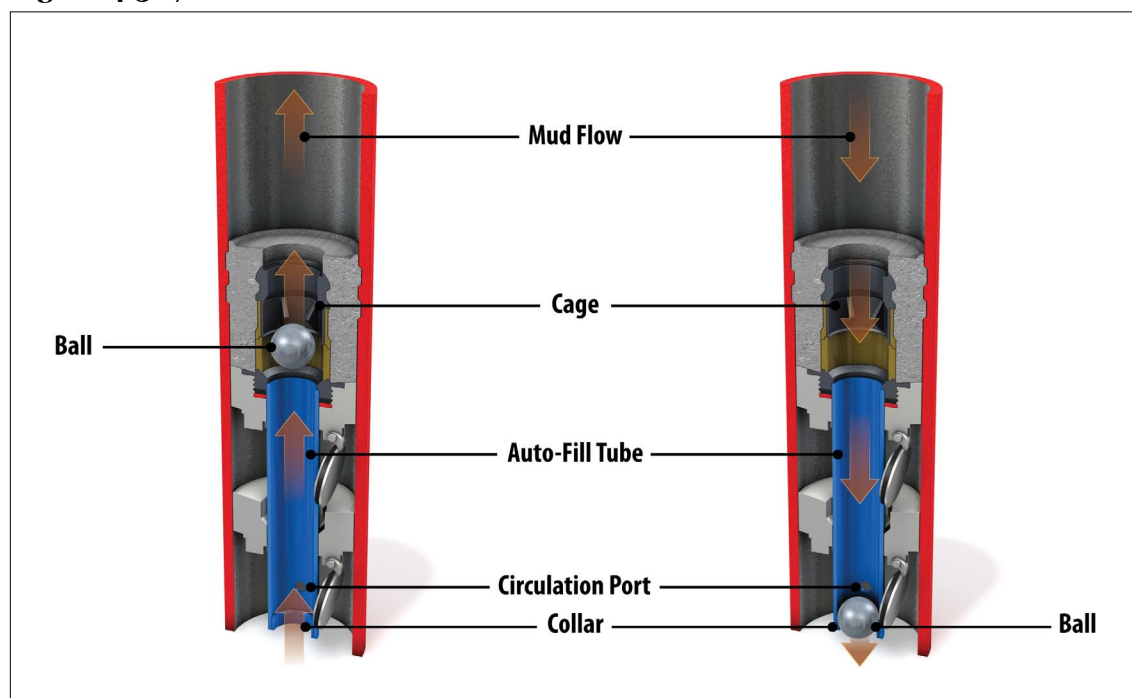
Figure 4.3.17. Auto-fill float collar.

The float collar's auto-fill tube contains a 2-inch weighted ball, which is free to move within the tube but not out of it. At the top of the float assembly is a plastic cage that prevents the ball from escaping but allows mud to flow through. At the bottom is a phenolic resin collar that is less than 2 inches in diameter, which also allows mud, but not the ball, to flow through. When casing is being run, mud flowing up through the tube pushes the ball against the inside of the cage. When the casing lands, the ball falls to and plugs the bottom of the tube, leaving two small holes on the side of the tube as the only path through the tube for mud circulated down through the well.¹⁴⁵

Flow while casing is being lowered (left) and flow during conversion (right).

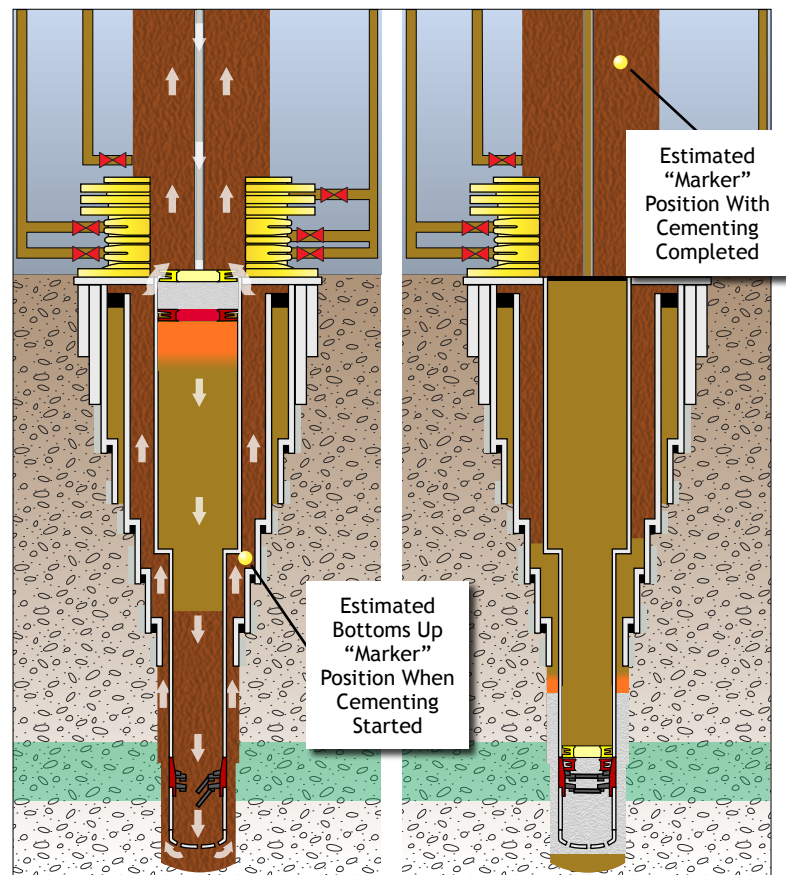
Figure 4.3.18. BP’s pre-cementing mud circulation.

At approximately 4:18 p.m. on April 19, the rig crew re-established mud circulation after running the long string.¹⁹⁹ The rig crew then circulated a total of approximately 350 barrels of mud at rates up to 4 bpm before beginning the cementing process.²⁰⁰ This figure exceeds the 261 bbl called for in the April 18 Halliburton cement job procedure²⁰¹ but is significantly lower than the 2,760 bbl required for a full bottoms up.²⁰²

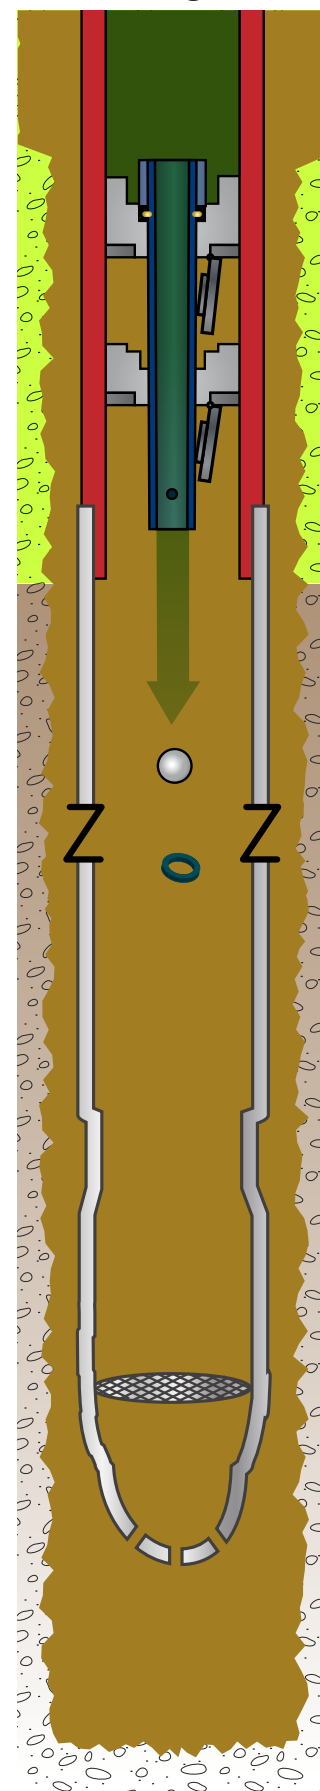
Figure 4.3.21. Ball forced through tube.

A second possibility, shown in Figure 4.3.21, is that the sudden pressure drop may have been caused when pump pressure forced the ball inside the auto-fill tube through the end of the auto-fill tube. The collar that would normally have retained the ball within the auto-fill tube was held in place with brass pins. It is possible those pins and the collar failed, allowing the ball to pass through.³⁰⁹ This would have left the auto-fill tube in place between the float valves and created a path for flow in either direction.

If the ports in the bottom of the auto-fill tube were clogged, the rig pumps may have placed enough force on the collar to shear the brass pins instead of the pins holding the auto-fill tube in place. Clawson informed Morel on April 19 that it would only take 1,300 psi of pressure to force the ball through the collar without converting the float valves.³¹⁰ It is not apparent whether Morel considered or informed others of this possibility.³¹¹

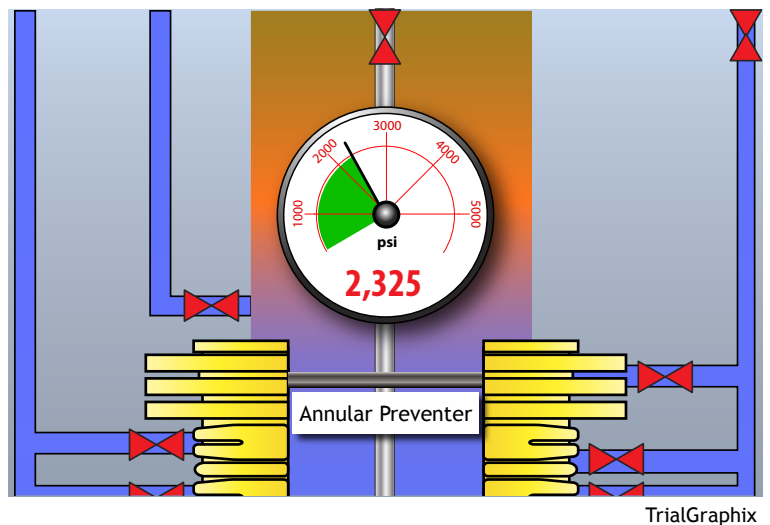
Figure 4.6.11. 4:53 p.m.

The crew closed the annular preventer around the drill pipe. The drill pipe pressure was approximately 700 psi higher than should have been expected, a sign that some spacer may have remained beneath the BOP.

Because the BOP and wellhead were a mile beneath the rig, the crew had no way of observing directly whether they had displaced all of the spacer above the annular preventer. But pressure readings on the drill pipe should have alerted them that something was amiss. When the crew first closed the annular preventer around the drill pipe (see Figure 4.6.11), the pressure on the drill pipe was approximately 700 psi higher than it should have been.²⁸ That anomaly should have merited further investigation because it could have indicated that spacer remained below the BOP. But it does not appear that anyone in the drill shack had ever calculated what the drill pipe pressure should have been.²⁹

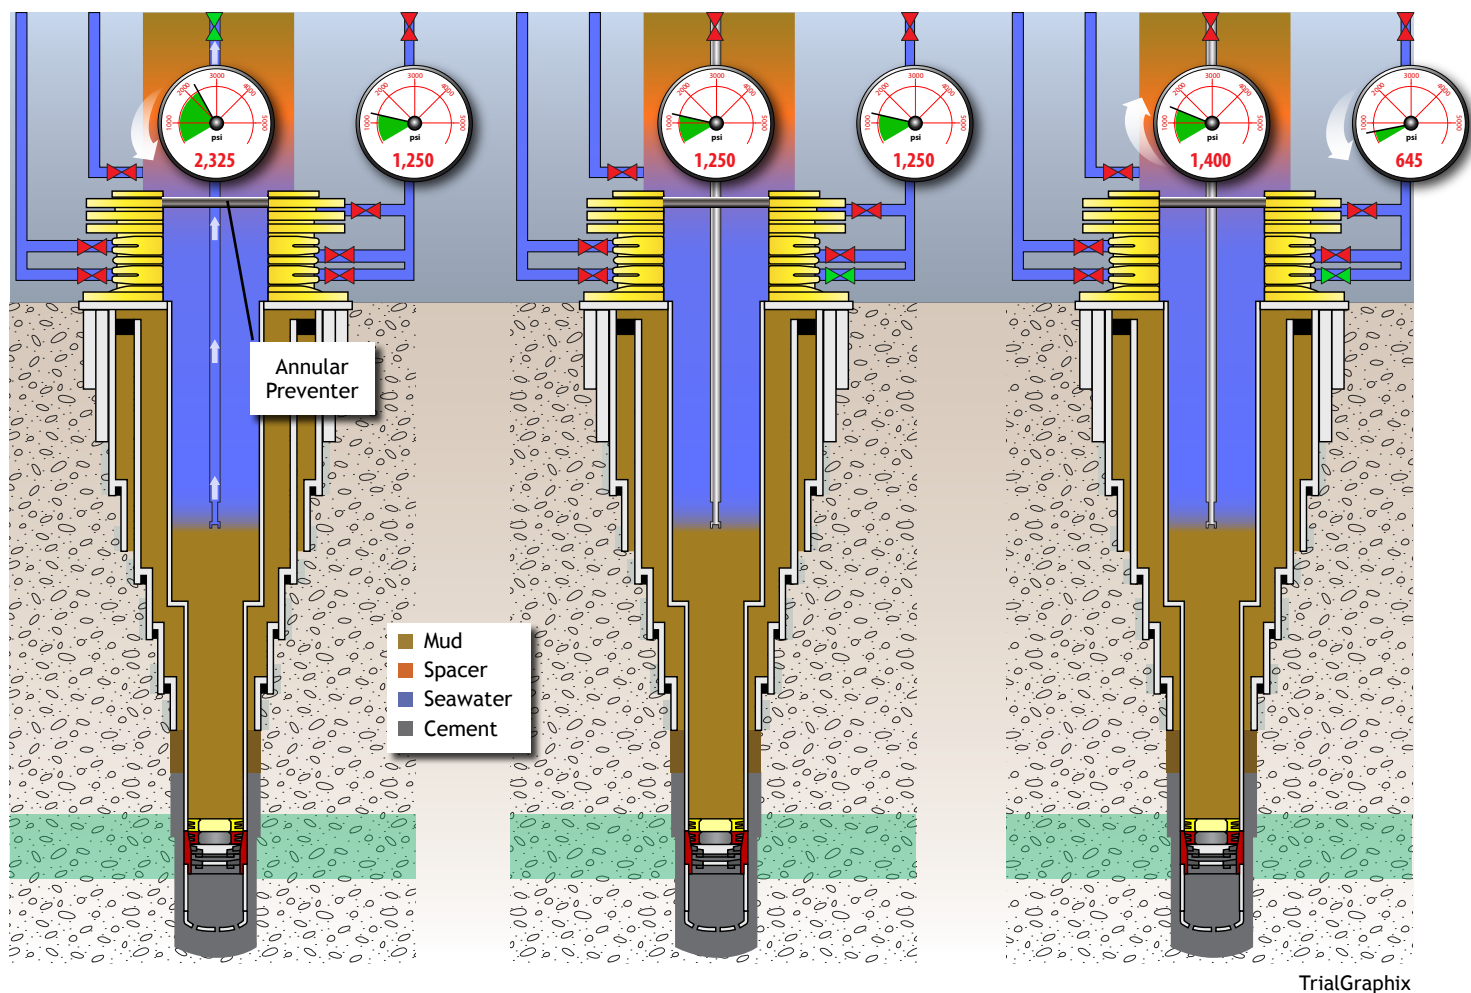
Figure 4.6.12. 4:55 p.m.

After the annular preventer was closed (left) the crew bled down the pressure in the drill pipe to equalize its pressure with the pressure in the kill line. Because both the drill pipe and the kill line go to the same vessel, when the valve connecting the kill line to the BOP is opened, the pressures should remain equal (middle). Instead, when the valve was opened, the pressures diverged (right).

The rig crew next bled the drill pipe to 1,250 psi, in an effort to equalize pressure on the drill pipe with pressure on the kill line (which was 1,250 psi at the time, as shown in Figure 4.6.12).³⁰ Once the crew had bled the drill pipe pressure down to 1,250 psi, it opened a valve on the kill line at the BOP so that both the drill pipe and kill line were open to the well. At this point, the drill pipe and kill line should have behaved like two straws in the same glass of water: The pressure in both should have been a steady 1,250 psi. Instead, when rig personnel opened the valve, the drill pipe pressure jumped, and the kill line pressure dropped.³¹

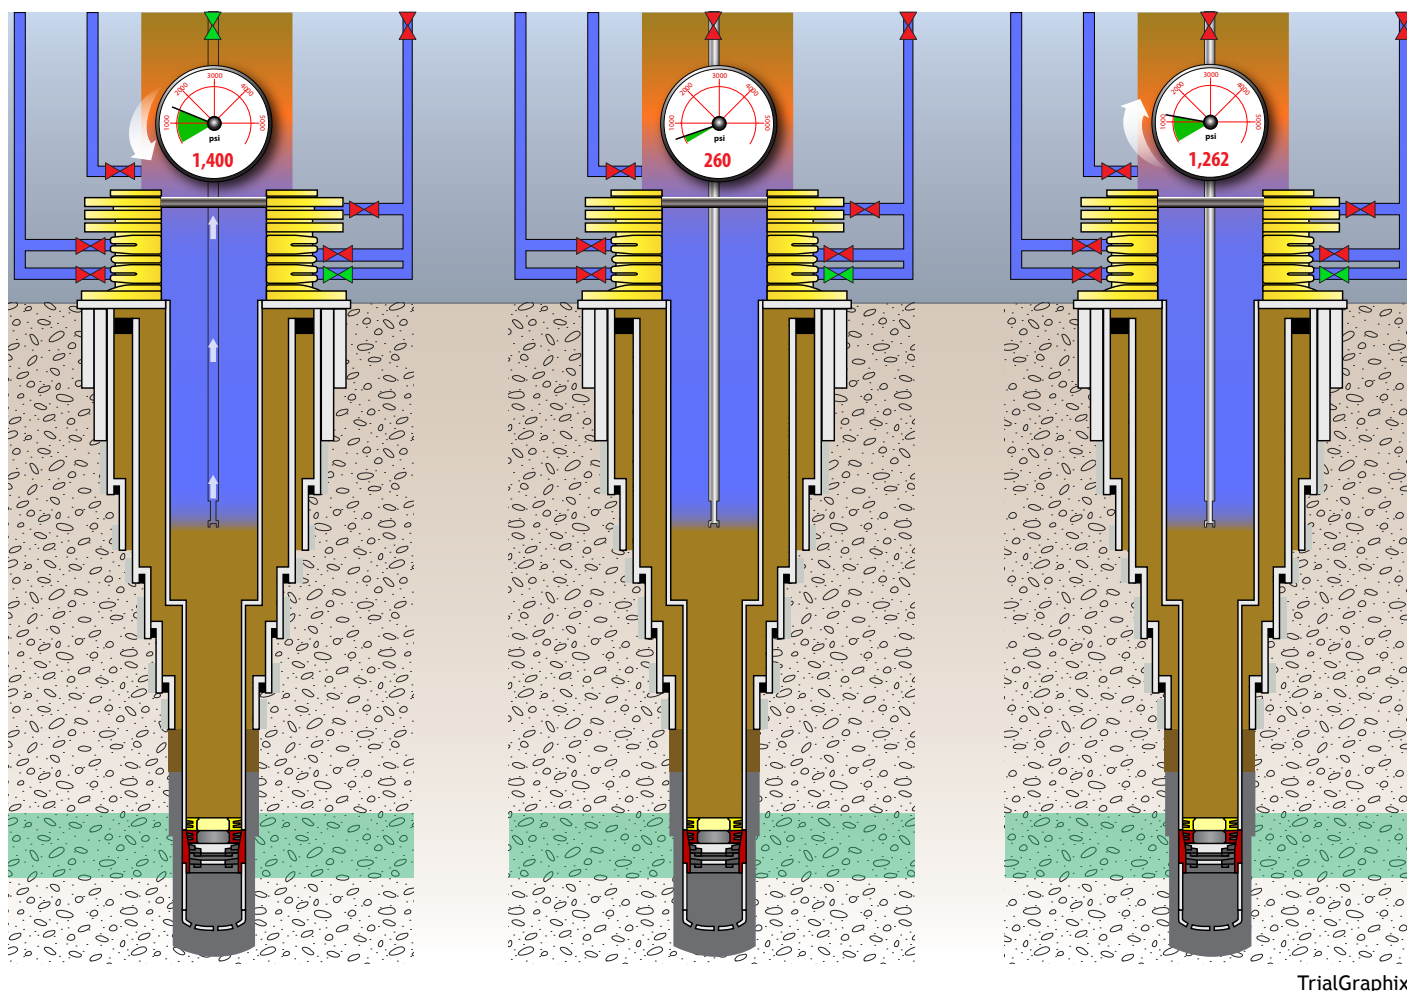
Figure 4.6.13. 4:58 p.m.

The crew began the negative pressure test by attempting to bleed the drill pipe pressure to 0 psi (left). However, the crew was unable to reduce pressure to below 260 psi (middle). This bleed returned an unknown amount of water to the rig. The crew shut in the drill pipe, and the pressure built up to 1,262 psi (right). In a successful negative pressure test, pressure does not build up.

As one independent expert has pointed out, this series of events actually constituted a failed negative pressure test, although the crew did not recognize that fact.⁴⁰

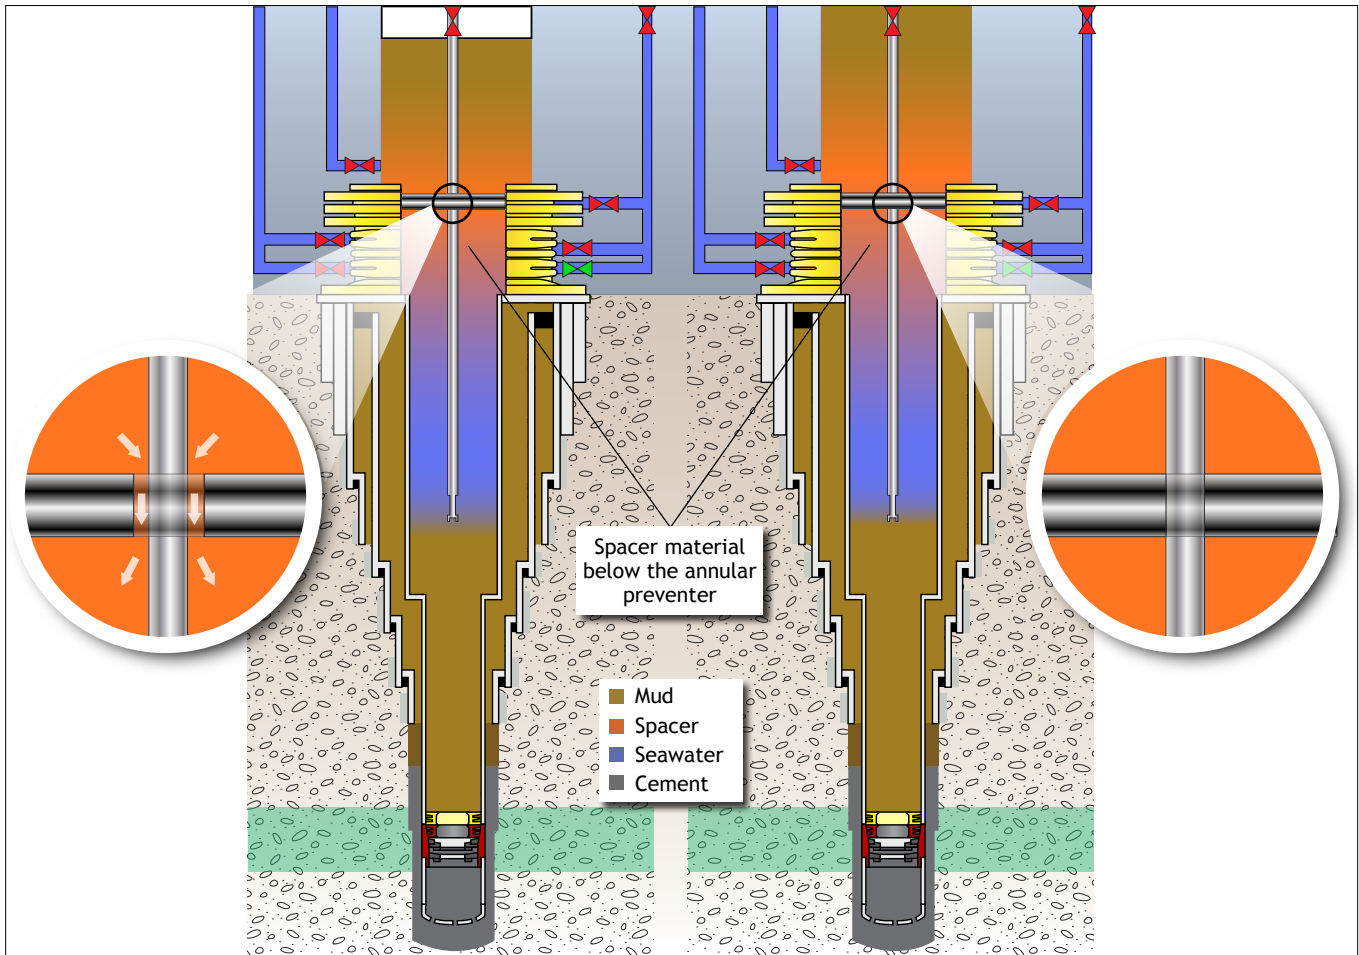
Figure 4.6.14. 5:10 p.m.

The rig crew noticed that the fluid level in the riser was falling. Because the annular preventer was not sufficiently tight around the drill pipe, spacer fell beneath the BOP (left). In response, the rig crew tightened the seal of the annular preventer and refilled the riser (right), but did not circulate the spacer back above the BOP.

At 5:10 p.m., the rig crew apparently noticed that the level of fluid in the riser was falling.⁴¹ Spacer in the riser was leaking down through the annular preventer and into the well below the BOP.⁴² Unlike many other indications, the crew could observe the fluid levels in the riser with their own eyes. When one rig crew member arrived on the rig floor, he saw others standing around the rotary table and using a flashlight to peer down into the riser to see how much fluid was missing.⁴³

Despite clear evidence that spacer had probably leaked below the BOP, rig personnel again did nothing to ensure that they had fully displaced the spacer above the BOP and instead proceeded with the test.⁴⁹

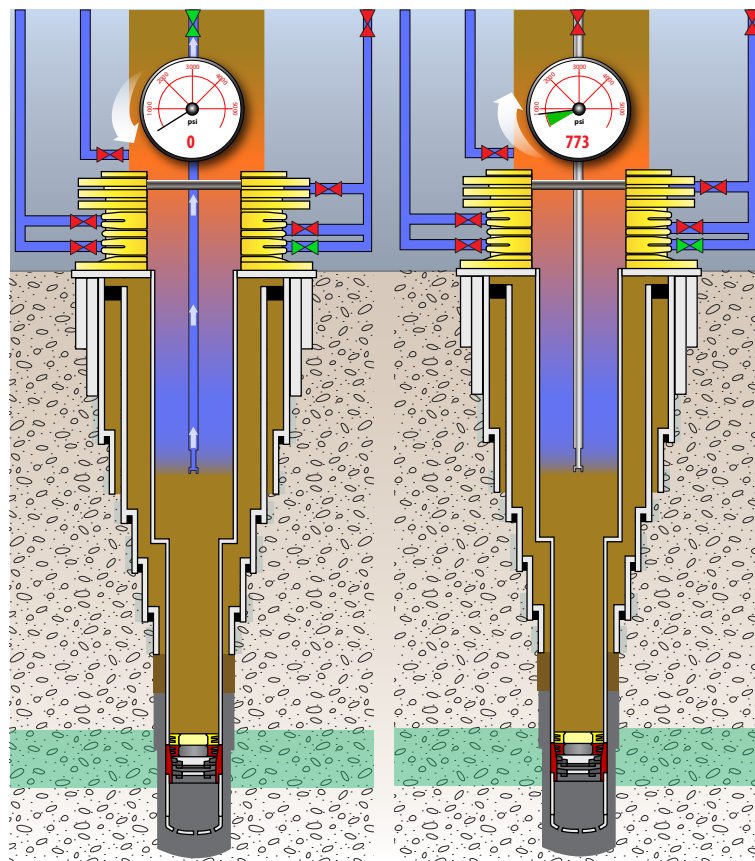
Figure 4.6.15. 5:26 p.m.

This second series of bleed-offs, excessive flows, and pressure buildups constituted another failed “negative pressure test” that the crew again did not recognize as such. With the annular preventer fully closed and sealed, the only explanation for the excessive returns and pressure increase would be that the primary cement job had failed to seal off the pay zone. Hydrocarbons were leaking from the formation into the well. Individuals involved in the test at this point should have recognized that the well lacked integrity.

The rig crew attempted again, this time successfully, to bleed the drill pipe pressure down to 0 psi. Fifteen barrels of seawater were returned during this bleed (left). The drill pipe was shut in, but the drill pipe pressure rose to 773 psi. Fifteen barrels is a higher return than should have been expected, and the drill pipe pressure should not have built back up.

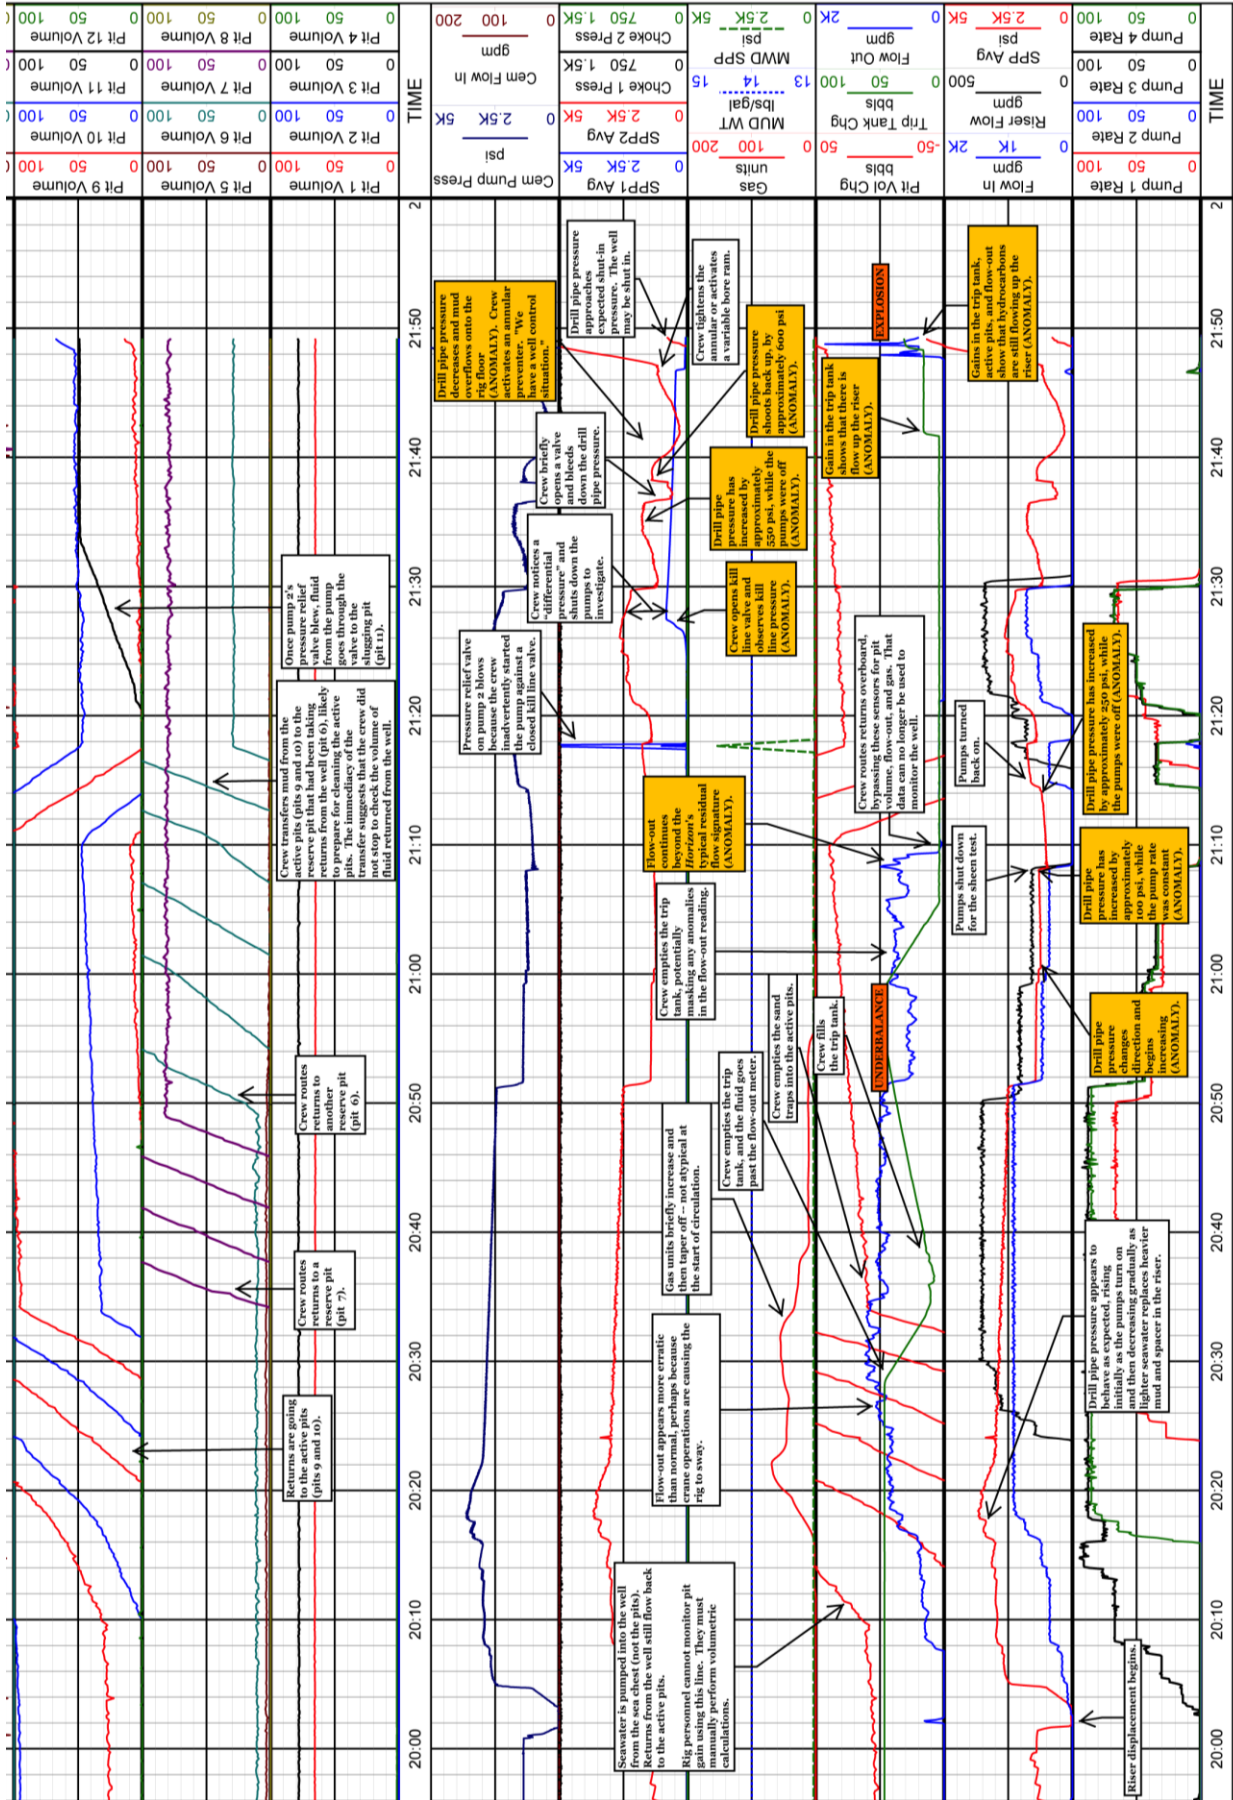
Figure 4.7.12. Last two hours of Sperry-Sun data.

The data available to rig personnel showed clear indications of a kick.²⁰⁹ The change in direction of drill pipe pressure (9:01 p.m.) and its subsequent steady increases (9:01 to 9:08 p.m., 9:08 to 9:14 p.m.) should have been a cause for concern but apparently went unnoticed. Even after the drill crew noticed an anomaly (9:30 p.m.), they do not appear to have seriously considered the possibility that a kick was occurring.

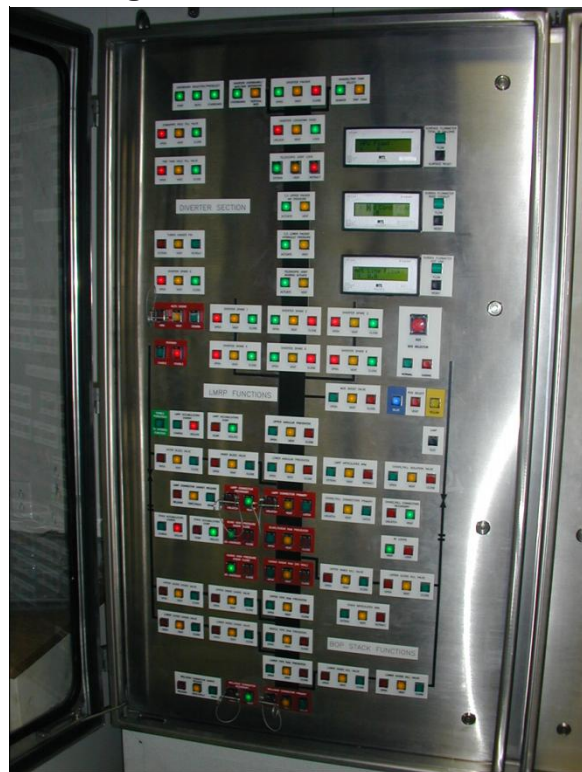
Figures 4.8.2 and 4.8.3.
BOP control panels on the rig floor and bridge.

In addition to activating the annular preventers or pipe rams, the crew could have activated the blind shear ram to cut the drill pipe and shut in the well.⁵⁴ The blind shear ram can be activated directly by the rig crew from the control panels, seen in Figures 4.8.2 and 4.8.3.⁵⁵ There is no evidence the rig crew attempted to activate the blind shear ram prior to the explosion.⁵⁶

The blind shear ram can be activated from the BOP’s control panels on the rig floor and bridge.

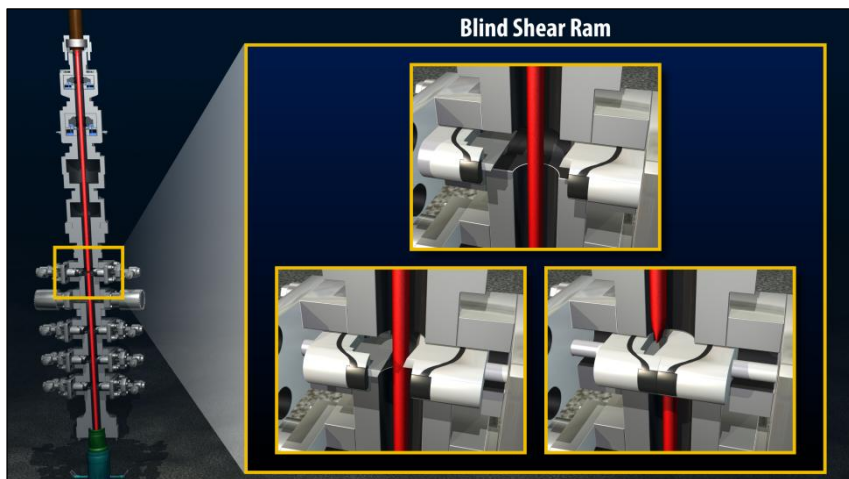
Figure 4.9.4. Blind shear ram.

The *Horizon's* blowout preventer had only one blind shear ram. Sections of drill pipe are joined by a tool joint at each interval and are often about 30 feet in length, though some of the drill pipe used on the *Horizon* varied in length.⁶ If one of those joints was in the path of the blind shear ram at the time of attempted activation, as portrayed in Figure 4.9.5, the ram would have been unable to shear the pipe and shut in the well.
